# Manhole Inspection Summary

Manhole # S51K\_\_034MH

Insp Date: **3/28/08 11:01 AM**

**Location** Address: **rear 2714 faith ave**

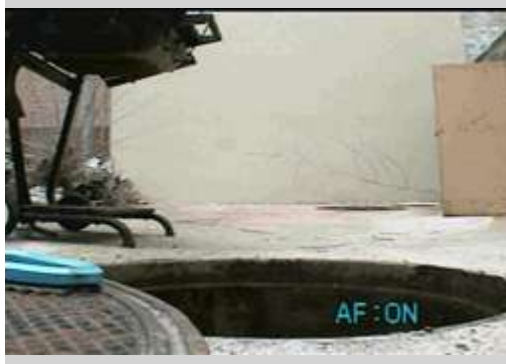
Location View

end of alley

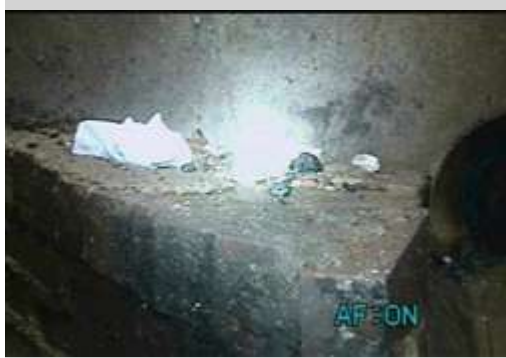
misc

bench debris

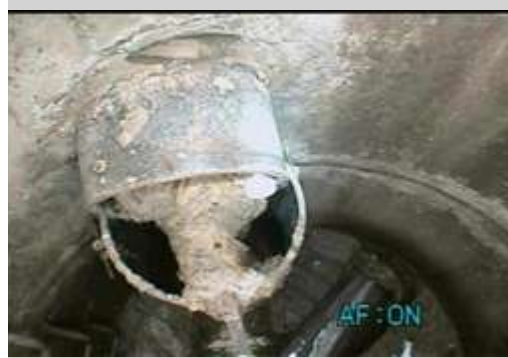
MISC.

View from top of Pipe In @ 4

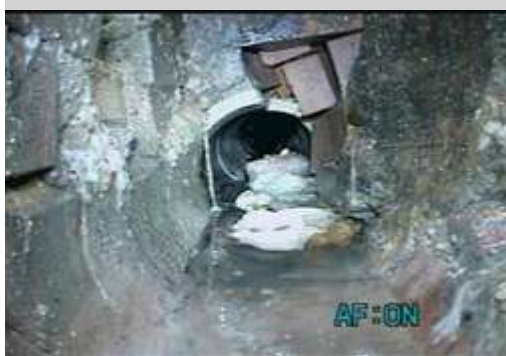
Defect 4

Condition: ☐ Sound ☐ Cracked ☐ Root Intrusion ☒ **Loose Brick** ☒ **Deteriorated**

channel debris & lose brick above 12

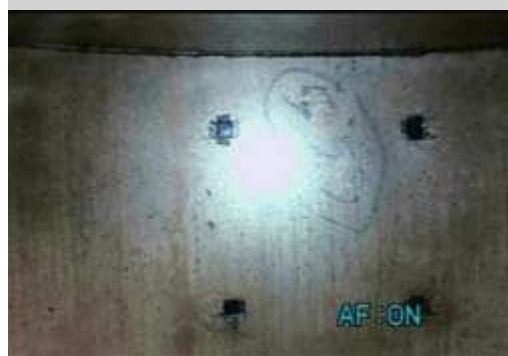
Defect

**Steps** Count: **6** Missing: **0** ☒ **Corroded**

cut off steps, others are corroded

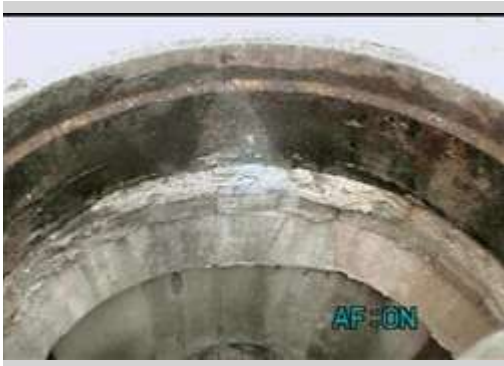
### Defect 1

**Frame** Offset: **1** (in.) Condition: ☒ Sound ☐ Cracked ☐ Leaks

frame offset

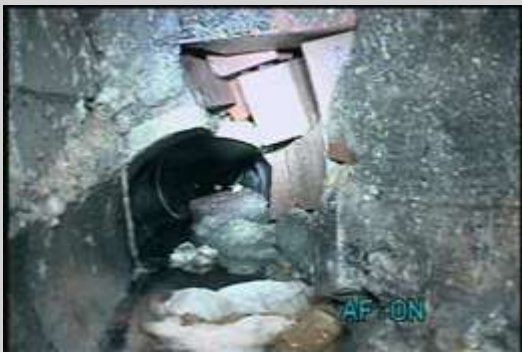
12 O'Clock Outflow

Pipe Height: **0** (in.) Direct  
Pipe Material: **Clay** ☐ Pipe Lined  
Invert Depth: **9.63** (ft.) Flow Characteristics: **Fast**  
Deposits: ☐ None ☐ Mud ☐ Sludge ☒ **Debris** ☐ Grease  
Silt Depth: **3** (in.) Deposits Extent: **Medium**  
Infiltration: **None** Pipe Seal Cond: **Unknown**

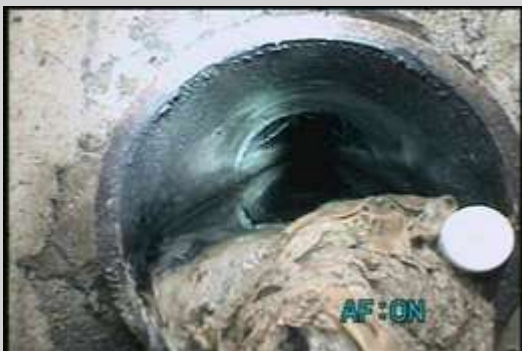
4 O'Clock Inflow

Pipe Height: **0** (in.) Direct  
Pipe Material: **PVC** ☐ Pipe Lined  
Invert Depth: **4.54** (ft.) Flow Characteristics: **Fast**  
Deposits: ☐ None ☐ Mud ☒ **Sludge** ☒ **Debris** ☐ Grease  
Silt Depth: **8** (in.) Deposits Extent: **Heavy**  
Infiltration: **None** Pipe Seal Cond: **Unknown**

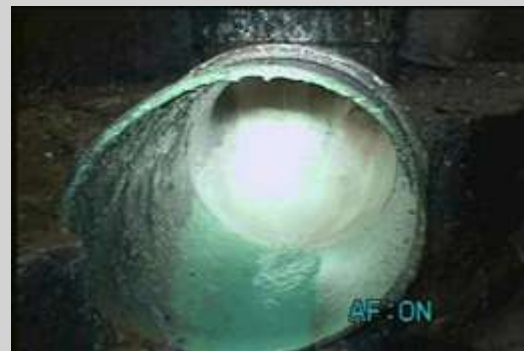
Drop In @ 4 O'Clock

bottom of Pipe 4

Drop: **Inside** **Direct**  
Angled: Reading: **0.00** (ft.)  
Inv Depth: **9.46** (ft.)  
Drop Condition: **Partly Clogged**
